**CITY OF SURPRISE**  
**Arts & Cultural Advisory Commission**  
**16089 N Bullard Ave,**  
**Surprise, AZ 85374**  
Monday, November 4, 2024 @ 6:00 PM  
Surprise Regional Library

The City contracted an outside art consultant, RLA Conservation, to conduct a survey of the current works of art collection. The survey includes an evaluation of replacement and restoration costs and a multi-year maintenance plan. The survey also includes a prioritization of maintenance and restoration needs. Commissioners completed a survey to evaluate the curatorial priority of each artwork.

The following report contains the results of a sculpture conservation survey conducted in late April 2024 for the City of Surprise, Arizona's Art in Public Places Program (hereafter referred to as the City). The purpose of the survey was to examine thirty-two (32) distinct works of art under the City's care (artworks selected by the City), determine the current condition of the artworks, and identify damaging factors that may be contributing to the artwork's deterioration. Where applicable, general cost ranges for treatment were calculated to provide an estimate of the scope of funding that would be required to ac

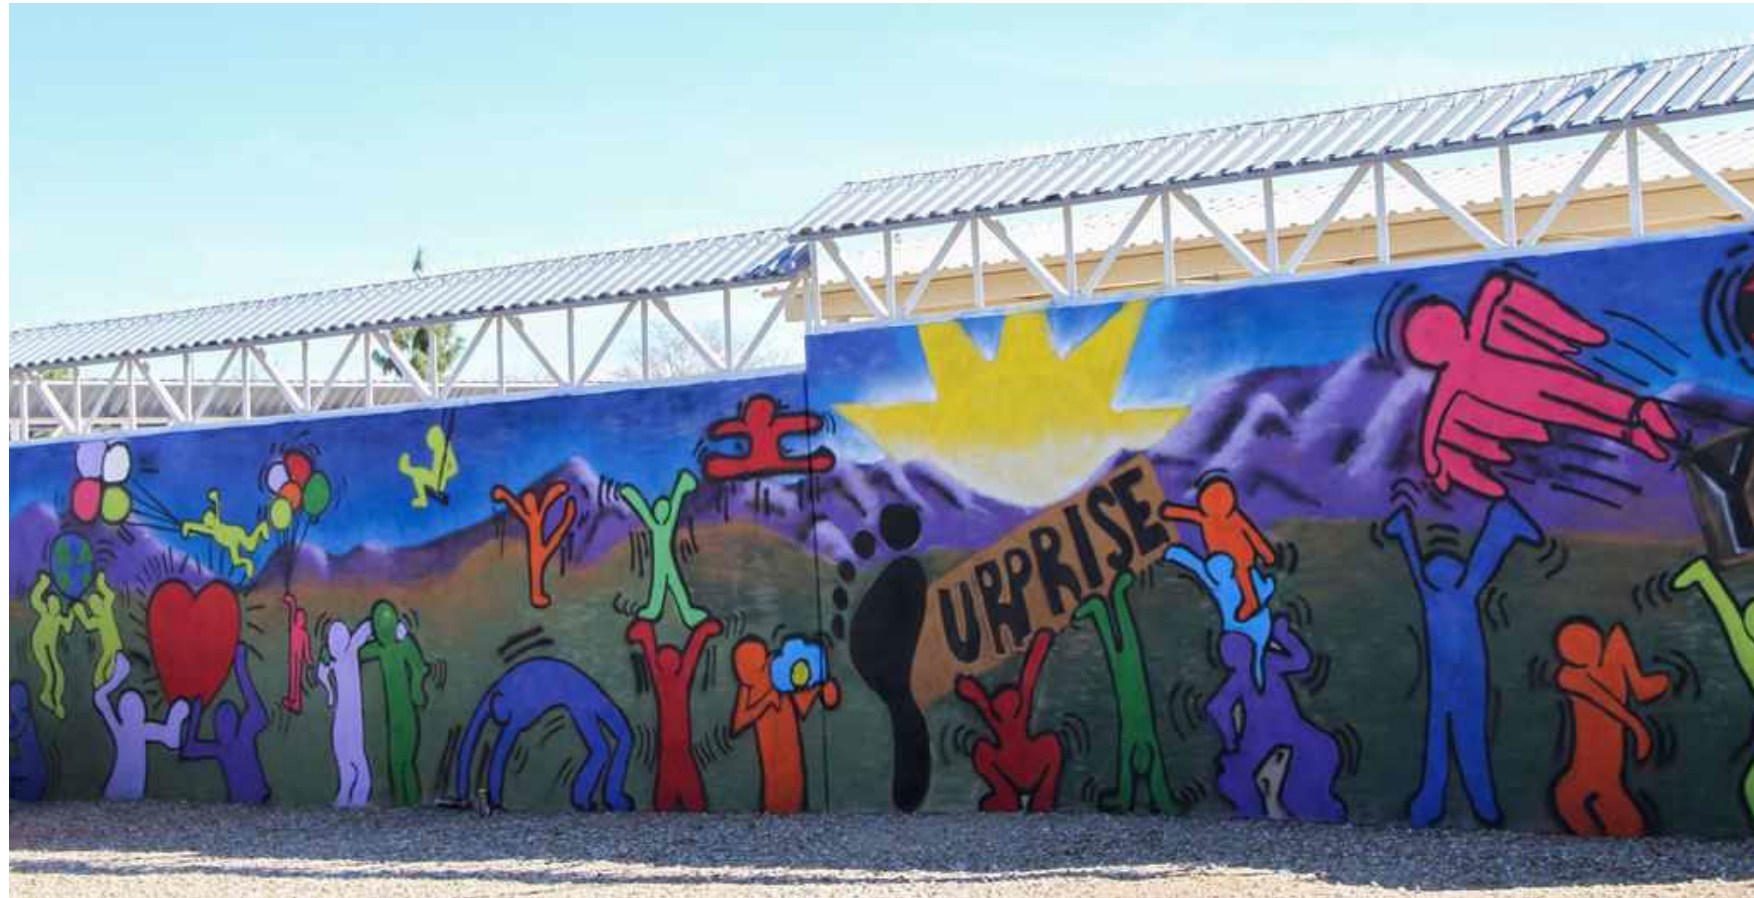
## Be Yourself, Find Your Crowd

- Restoration = 4x Replacement
- LOW curatorial priority (4)
- Issues with wall damage
- Concerns with original design inspiration
