**CITY OF SURPRISE**  
**Arts & Cultural Advisory Commission**  
**16089 N Bullard Ave,**  
**Surprise, AZ 85374**  
Monday, November 4, 2024 @ 6:00 PM  
Surprise Regional Library

The City contracted an outside art consultant, RLA Conservation, to conduct a survey of the current works of art collection. The survey includes an evaluation of replacement and restoration costs and a multi-year maintenance plan. The survey also includes a prioritization of maintenance and restoration needs. Commissioners completed a survey to evaluate the curatorial priority of each artwork.

The following report contains the results of a sculpture conservation survey conducted in late April 2024 for the City of Surprise, Arizona's Art in Public Places Program (hereafter referred to as the City). The purpose of the survey was to examine thirty-two (32) distinct works of art under the City's care (artworks selected by the City), determine the current condition of the artworks, and identify damaging factors that may be contributing to the artwork's deterioration. Where applicable, general cost ranges for treatment were calculated to provide an estimate of the scope of funding that would be required to ac

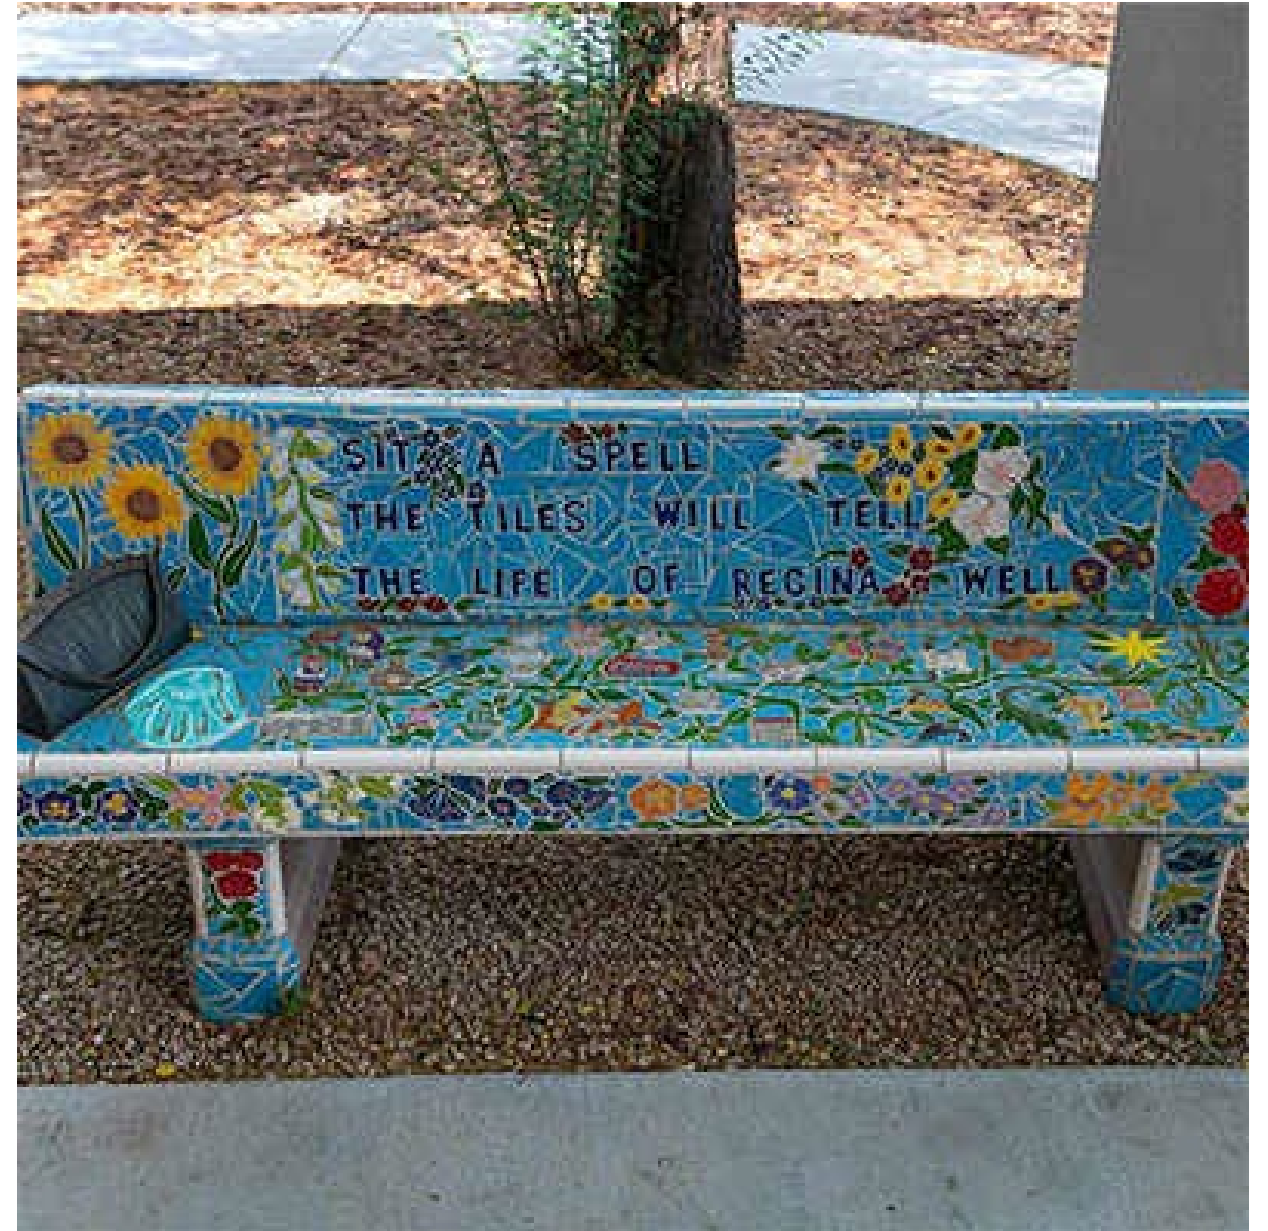
## Regina Well Memorial Bench

- Restoration = 5x Replacement
- HIGH curatorial priority
- Biological growth

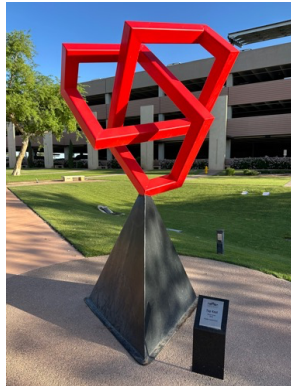
**Location:** 16000 N. Civic Center Plaza (City Hall)

**General Condition:**    Excellent            Good            Fair X            Poor

**Condition:** Overall, the sculpture appears to be structurally sound and securely mounted. The surface condition is fair. There are moderate accumulations of ferrous corrosion around the base of the sculpture at the flange that is used to connect the artwork to the surrounding pavement. Though sprinklers were not on during the assessment, they were observed in other parts of the grassy lawn. It is likely that sprinkler water over sprays and hits the sculpture frequently. Because of the tight connection between the base and the concrete, water is likely trapped along the underside of the base, which promotes corrosion. The pavement along this connection was visibly wet at the time of assessment. There is also evidence of mineral deposit buildup on the underside of the red sculptural element as well as throughout the sides of the pyramidal base. The base also appears somewhat faded and discolored, likely due to prolonged, strong UV exposure. There are copious amounts of scuff marks, abrasions, and scratches throughout the base due to public interaction. There are two small areas of powder coating loss on the red sculptural elements on the side facing the pedestrian pathway. In this area, the mild steel base metal is exposed. There is also a small hole on the north side of the sculpture that is inherent to the original fabrication. Ferrous corrosion runoff

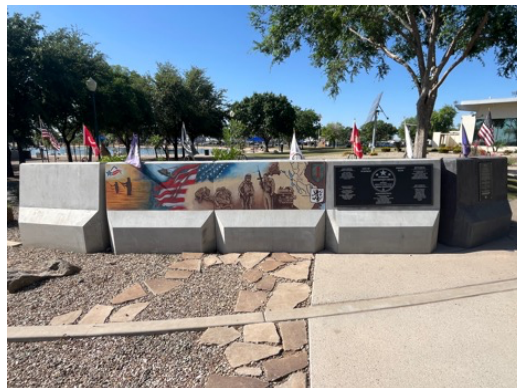
**Location:** 16089 N. Bullard Ave. (Veterans Reflection Circle, north of the Surprise Regional Library)

**General Condition:**    Excellent            Good            Fair X            Poor

**Condition:** Overall, while the concrete substrates are structurally sound, the condition of the murals is fair. Each concrete jersey barrier block is intact. There are multiple hairline cracks visible throughout, which naturally occurs in cement over time. There are three (3) small areas of concrete and paint loss on the north side, and several areas along cracks where the paint is flaking. Along other hairline cracks in the surface, the paint appears to be cracking and slightly lifting/curling as well. These could be areas of future paint loss if not stabilized. Overall, the work appears to have a fairly matte appearance. The artists state that the intended sheen is matte to satin. Therefore, the work has become more matte over time, likely due to prolonged sun exposure. Per the artists, they estimated the color vividness life expectancy to be 3-5 years provided the murals are not exposed to direct sunlight. They did recommend annual re-application of the Behr® Premium Low-Luster sealer at no more than

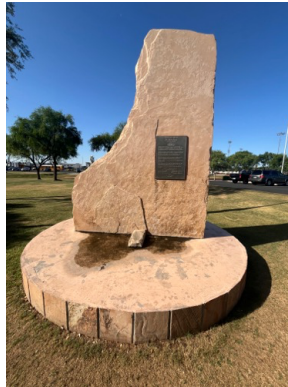
**Location:** 15953 N. Bullard Avenue (Surprise Community Park/ Decommissioned Fighter Airfield)

**General Condition:**    Excellent            Good            Fair X            Poor

**Condition:** Overall, the artwork is in fair condition. The larger structure of the installation appears to be stable. The surface of the vertical stone is in relatively good condition. These elements appear to be face-bedded sandstone, so delamination of the stone layers may occur over time as the material ages. There appears to be a fragment of stone missing from the top visual right corner when viewed from the south, however that could be inherent to the stone. The sides show a few hairline cracks. Dried bird droppings are visible towards the top of the stone. There are moderate accumulations of surface soiling present.

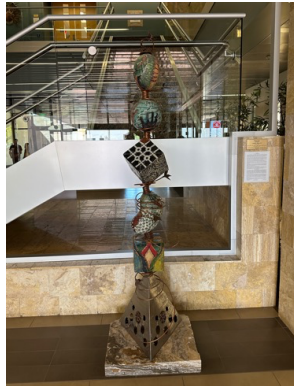
**Location:** 16000 N. Civic Center Plaza (City Hall)

**General Condition:**    Excellent            Good X            Fair            Poor

**Condition:** Overall, the sculpture appears to be structurally sound and in relatively good condition. There is an area of missing Encaustic Wax measuring approximately half an inch in area (1/2") at the vertical edge of the lotus box form, facing the stairs. Moderate accumulations of dust and cobwebs were noted throughout the installation with the heaviest accumulations occurring on skyward-facing surfaces. Localized areas of blue green copper

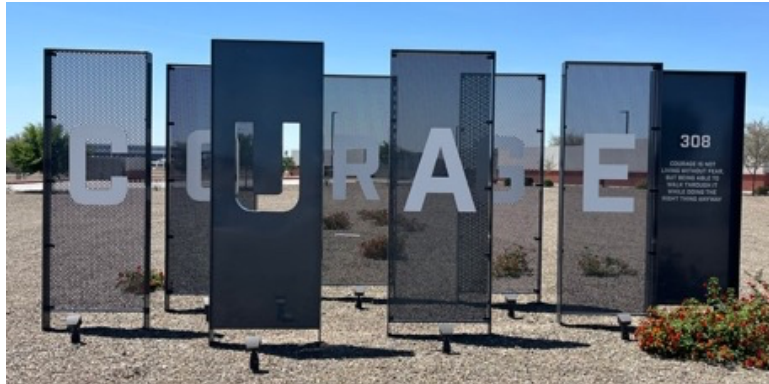
**Location:** 13771 W. Cactus Rd. (Fire Station #308)

**General Condition:**   Excellent           Good X           Fair           Poor

**Condition:** Overall, the artwork is in relatively good condition and structurally stable. There are many small areas of localized corrosion specifically near torx screws, near the upper corner of the letter "U," and along the bottom of the far visual right panel. This lower area is due to abrasion. There are a few scratches on the sides and backs of the panel that exhibit corrosion. The clear coating on each panel appears to be crazing in multiple areas especially along the sides and around torx screws. There are some areas around torx screws where the paint coating is visibly flaking off. It is likely that multiple screws were overtightened or the threads cut into the paint coating, allowing corrosion to take hold. Paint coatings are also notoriously thinner along sharp edges/right angles, because surface tension pulls the paint away from these corners. As such, the City will likely see additional corrosion forming along the many sharp edges of the perforated steel as the work ages. The middle panel with the letter "U" displays a gap in the seam along the base of the letter "U." There are light accumulations of surface soiling, spider webs, and insect nests visible throughout. The above-ground up-lighting was not on at the time of assessment during the day, so it is unknown if the lights are functional at night.

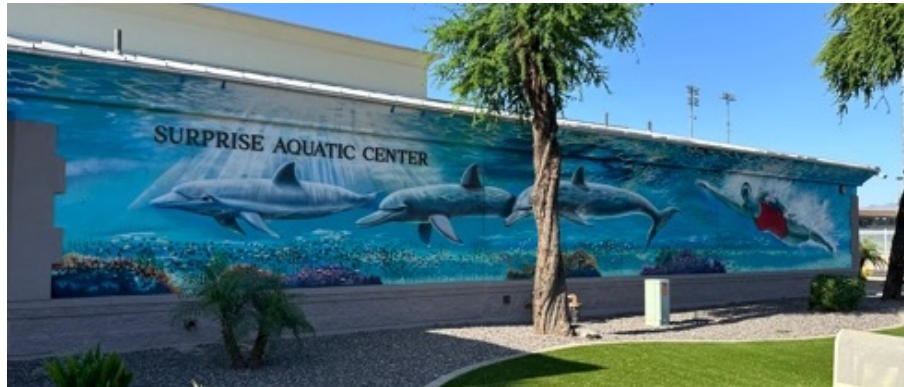
**Location:** 15831 N. Bullard Ave. (Surprise Aquatic Center)

**General Condition:**    Excellent            Good X            Fair            Poor

**Condition:** Overall, the mural appears to be in relatively good condition. Along the roofline, there are multiple vertical hairline cracks in the stucco, likely along seams that appear to be the result of settling or expansion. There is one (1) area at the east side of the mural where there are two (2) indentations in the stucco wall that have damaged the mural. There are several small losses of paint on the entryway columns as well as gum stuck to the mural surfaces. There is paint applied to the flexible sealant in the stucco expansion joints along the walls which exhibits cracking throughout the surfaces. Near the entryway, there is one (1) area of missing paint along the west side of the entry along the flexible sealant. In recesses along the roofline, there are multiple insect nests. Plant debris and other surface soiling was noted throughout the artwork with heavier concentrations along the bottom recesses and overhangs of the roofline. The artist recommends in their maintenance manual that the mural be re-coated with the Modern Masters® Urethane Satin Clear coating via spray per the manufacturer's specifications, though the frequency of re-application is not specified. They concede that areas where fluorescent paint was used will fade more quickly than other colors.

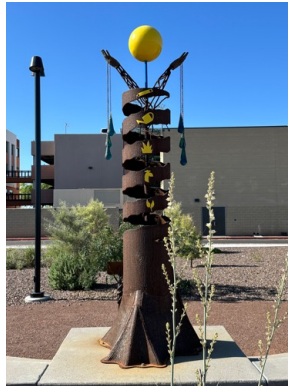
**Location:** 16080 N. Civic Center Plaza (Xeriscape Demonstration Garden)

**General Condition:**   Excellent           Good X           Fair           Poor

All of the exposed mild steel elements have been allowed to rust naturally. There may be a clear protective coating to arrest progression of the corrosion “patina” that they desired.

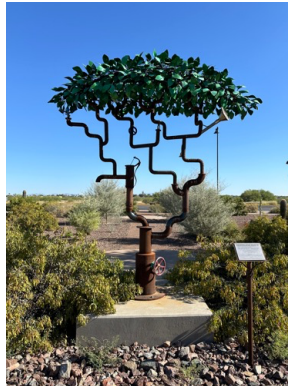
**Location:** 16080 N. Civic Center Plaza (Xeriscape Demonstration Garden)

**General Condition:**    Excellent                      Good X                      Fair                      Poor

**Condition:** Overall, the sculpture appears to be in relatively good condition and structurally stable. Ferrous corrosion continues to develop throughout the work, with corrosion runoff staining visible running down onto the surfaces of the canopy leaves and on the surrounding concrete pad. On the hand water pump, the corrosion is resulting in surface material flaking and delaminating from the body of the element. The work was viewed from ground level, so we were not able to see if there is damage occurring on the top-most surfaces of the canopy. Corrosion was also noted forming on the stainless steel mounting hardware. The red coating

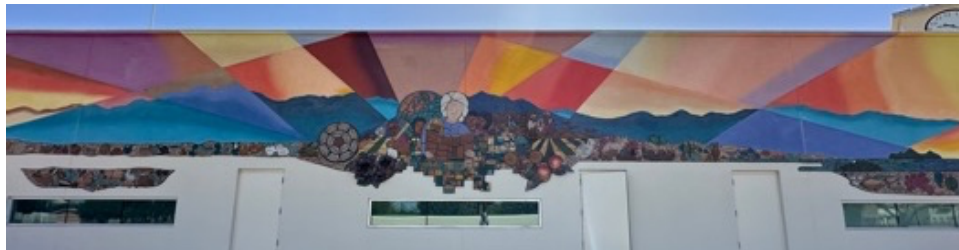
**Location:** 16089 N Bullard Avenue (Northwest Regional Library)

**General Condition:**   Excellent           Good           Fair X           Poor

**Condition:** The mural was assessed from ground level using binoculars and a camera with a zoom lens. Overall, the mural appears to be in fair to relatively good condition with no major structural concerns noted. It appears that one (1) glazed ceramic tile is missing toward the visual right side of the mural, above the bird and its nest. White thinset mortar is visible where the missing tile was originally located. One (1) tile in the central woman figure's hair appears to be cracked in half vertically. Multiple cracks were observed in the grout and along

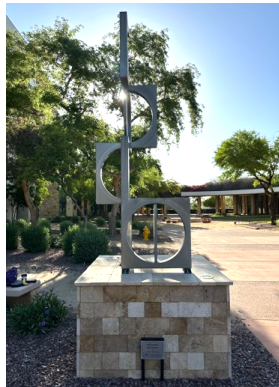
**Location:** 16000 N. Civic Center Plaza (City Hall)

**General Condition:**    Excellent            Good            Fair X            Poor

**Condition:** The sculpture appears to be structurally sound and secure on its mount. The surface condition is fair. The applied glossy clear coating has severely degraded on the west, south, and west surfaces of the artwork. The north facing side is still relatively glossy. There is a large building immediately north of the sculpture that likely helps block additional sunlight. There are swaths of ferrous corrosion throughout the sculpture, predominantly on the south facing side where the coating is most deteriorated. Ferrous corrosion was also observed along almost every corner or edge, sometimes with larger swaths of corrosion working from the corner outward across the face of the metal. Corners are notoriously weak points on coated surfaces as the applied coating is inherently thinner in these areas due to surface tension pulling the coating back from the artwork edges. A strip of bird spike deterrent has been applied to the top horizontal surface of the sculpture. It is not visible how

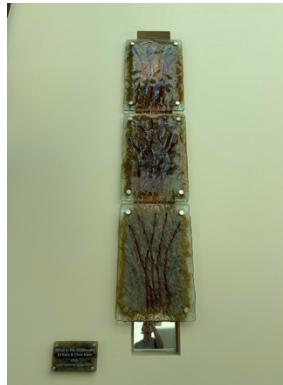
**Location:** 16000 N. Civic Center Plaza (City Hall – Mayor's Atrium)

**General Condition:**   Excellent           Good X           Fair           Poor

**Condition:** Overall, the installation appears to be structurally sound and secure on its mounts. Two (2) of the overhead lights in the recesses/niches are not on/working. It is unclear if the bulbs just need to be replaced or if there is an issue with wiring. Moderate to heavy accumulations of dust were noted on the skyward-facing surfaces of the top edge of the rectangles, the tops of the wall mounts/stand-offs, and the bottom of the wall recess/niche. One (1) of the mirrors exhibits surface soiling in a splatter/droplet pattern. Insect carcasses were noted within several niches.

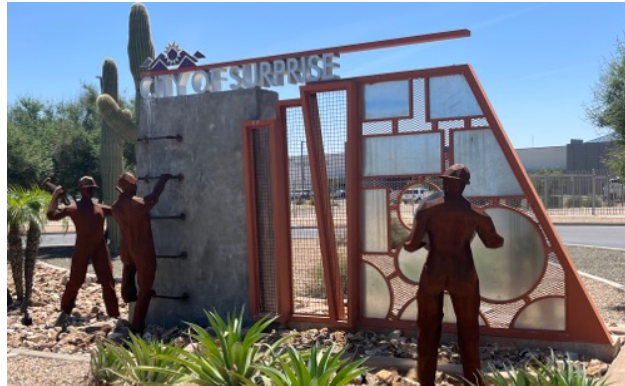
**Location:** 13659 Cactus Road (Public Works Operations Facility)

**General Condition:**    Excellent            Good X            Fair            Poor

**Condition:** Overall, the artwork figures are in good condition and the entire site appears to be structurally stable. The patina of weathering steel continues to develop. There are more "active" areas of corrosion occurring where water sheds off of the figures, leaving a drip-like pattern. This is naturally occurring and should be considered part of the intended patina development. Heavy accumulations of dried bird droppings are visible on the top of the heads of the figures. It is unknown if the droppings have etched into the surface of the weathering steel, though it is likely as they are very corrosive and weathering steel "patina" is very sensitive to disruptions in its formation, such as bird droppings, fingerprints,

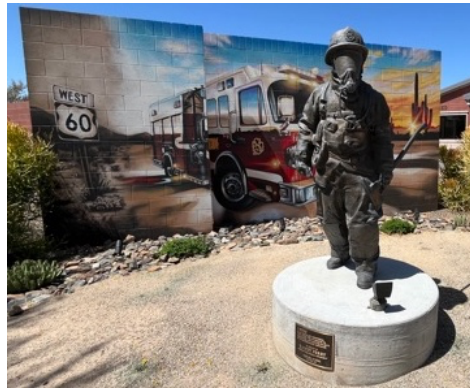
**Location:** 24550 N 163rd Drive (Surprise Fire Station #304)

**General Condition:**    Excellent    Good    X    Fair    Poor

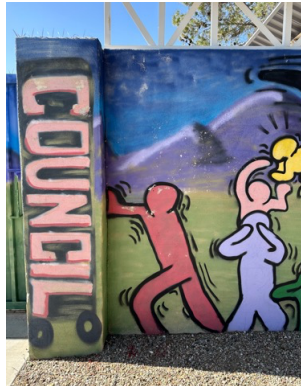
**Location:** 15960 N. Bullard Avenue (Well Retention Wall at Surprise Recreation Campus)

**General Condition:**    Excellent            Good            Fair X            Poor

**Condition:** Overall, the mural appears to be in fair condition. There are sizable areas of concrete missing where something (likely a vehicle) has struck the columns near the painted metal gates. Cracks are forming in the stucco and appear to be occurring along the CMU joints. There are multiple areas of paint loss with many areas of additional lifting/flaking and crazing paint. Some of the losses are less than one inch (1"), but some are several square inches in area. It is unknown if there was any primer applied before the mural was painted. There is extensive fading and discoloration of the colors throughout the mural. There does not appear to be any clear protective UV or anti-graffiti coating. Localized drips of bird droppings are present on the mural face where bird spikes are not present along the top of

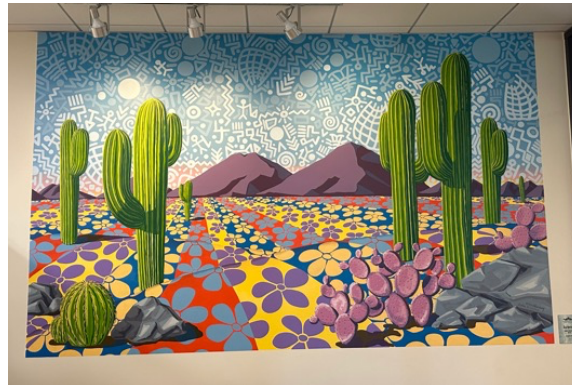
**Location:** 16000 N. Civic Center Plaza (City Cashier Office)

**General Condition:** Excellent X      Good      Fair      Poor

**Condition:** Overall, the mural appears to be in excellent condition. It has been painted directly onto an interior painted wall made of drywall. It is unknown if the wall was primed, what paints were used to create the mural, and/or if any protective clear coat was applied overtop. Even though the mural does not face any windows, it can still be susceptible to damage from UV and visible light from incandescent light bulbs.

**Recommended Site Improvements:** Switch any incandescent bulbs in the Cashier's Office to LED. Apply UV protective film over glass partition wall to Cashier's Office to block any ambient UV light from exterior windows or other incandescent lighting.

**Treatment Recommendations:** No treatment is warranted at this time.

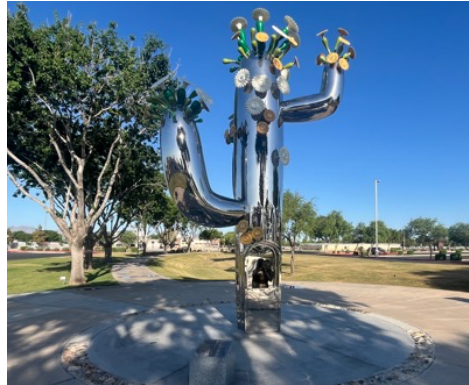
**Location:** Surprise Community Park

**General Condition:**    Excellent            Good X            Fair            Poor

**Condition:** Overall, the artwork appears to be in good condition and structurally stable. The stainless steel surface of the cactus figure is in good condition. The paint coating is intact and the colors do not yet appear to be affected by strong UV light. There are a few surface scratches on the lower half. One (1) of the green flower buds closest to the bottom above the bronze appears to be loose from its mount and drooping from the surface. Lower surfaces of the cactus exhibit heavy fingerprints, dust, surface soiling, and mineral deposits.

The bronze torso is in fair condition. The patina appears blotchy and uneven particularly on the arms. There is one (1) small area of corrosion at the figure's proper right hip. The head appears dry. The lacquer coating appears intact, though the darkening/tarnish of the bronze surfaces indicates that the coating is likely very thin. As such, the metal below is beginning

to oxidize. There are moderate amounts of surface soiling present on the bronze. The plaque appears to be in good condition as well with minor surface scratches present.

**Comments on Safety/Risk Management:** One of the flowers near the lower half of the artwork is loose. All of the blooms should be checked to make sure they are stable.

1. Document treatment with a written report and high-resolution photography. Provide recommendations for routine maintenance as well as a Dropbox link to all treatment images.
2. Dry brush surfaces to remove loose particulate matter and atmospheric soiling.
3. Clean all surfaces with a solution of distilled water and a conservation-grade detergent, using soft microfiber cloths suitable for the artwork's mirror-polished surface.
  - a. Rinse all surfaces with distilled water and dry with fresh microfiber cloths.

- b. Once clean, inspect surfaces for signs of tarnish, corrosion, scratches, or other possible damage.
4. Mitigate surface scratches using a polish suitable for stainless steel.

5. Work with City and/or certified electrician to trouble-shoot issues of uplighting and any inherent lighting in the artwork itself.
6. Remove hardware at loose flower/bloom element and re-secure. Replace hardware, fill hardware head, and in-paint to blend with other hardware on the installation.

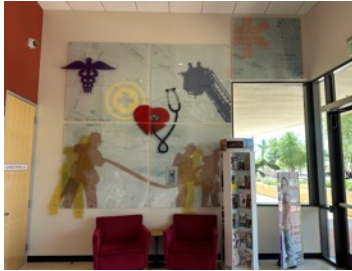
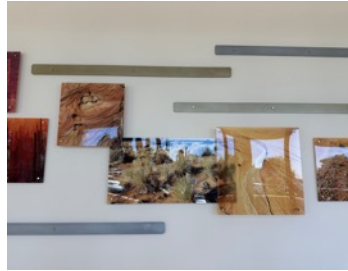
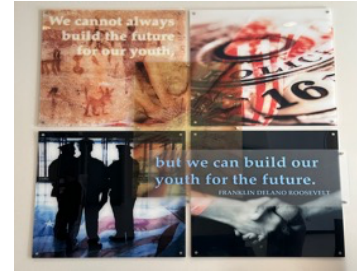
**Location:** 14250 W Statler Plaza (Public Safety Building)

**General Condition:**    Excellent            Good X            Fair            Poor

**Condition:** Overall, the installation elements appear to be in good condition and secure on their mounts. One panel in the corridor has been pushed in on its mount at one corner. The other mounts appear to be stable. Scuffs and abrasions were noted at lower panel surfaces where people pass in the corridor or furniture is placed in front of or near these panels. The most scratches were noted in the police department lobby, followed by the corridor and then then fire department/EMS lobby. Liquid splatter marks and other unidentifiable accretions were noted in localized areas across multiple panels. Some of the text on the panel in the police department lobby below the television screen is scratched and marred. The trio of panels above visitor seating does not seem fully engaged with the wall as threaded hardware is visible between the wall and column of the individual standoffs. There are inherent vice bubbles on the verso/printed sides of some panels that occurred during fabrication. Light accumulations of dust were noted throughout most surfaces, especially on the horizontal surfaces of the standoff mounts.

**Treatment Recommendations:** No treatment is warranted at this time. Damaged acrylic panels really cannot be treated with conventional conservation practices. It would be more successful and cost-efficient to have damaged individual panels re-printed/fabricated.

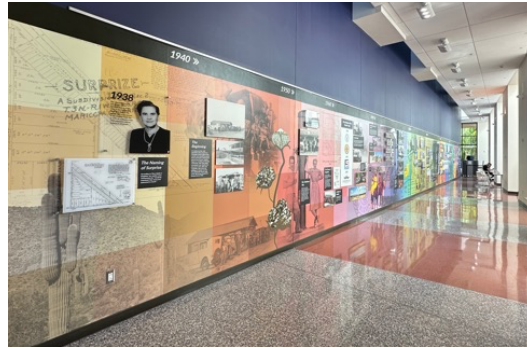
**Location:** 16000 N. Civic Center Plaza (City Hall- Mayor's Atrium)

**General Condition:**   Excellent           Good X           Fair           Poor

**Condition:** Overall, the installation appears to be in relatively good condition. There are localized areas throughout the installation where the printed vinyl is detaching from the wall, primarily along top and bottom edges as well as vertical seams. The vinyl is lifting along the edges and starting to curl back on itself. The stainless steel or aluminum channel along the top of the mural does not extend the full length of the installation. At both the visual left and right sides, it ends about one foot (1') short of the edge of the mural and wall corner. The acrylic and foam panels off-set from the wall appear secure. There are light dust accumulations on the horizontal surfaces. The items within the acrylic vitrines also seem secure. Dust was observed within all vitrines and insect carcasses were observed in the one with the stained glass window.

**Treatment Recommendations:** Not treatment is warranted at this time. The vinyl installer should be contacted about tacking down the edges of the vinyl sections so they do not continue to pull away from the wall.

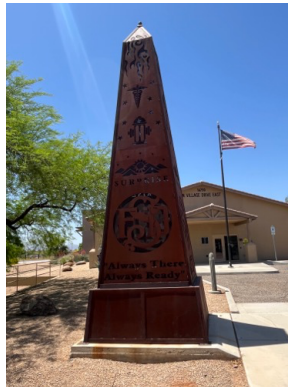
**Location:** 16750 N. Village Dr. (Fire Station #301)

**General Condition:**    Excellent            Good X            Fair            Poor

**Condition:** Overall, the artwork is in good condition, appears to be structurally stable, and is secure on its mount. The weathering steel is actively going through the cycles of corrosion and forming the more stable corrosion oxide layer. This is particularly visible on the undersides of edges and along seams where moisture likely collects and dwells on the surface. There are seams midway up the obelisk on each side that have been likely treated by the artist to blend with adjacent surfaces but appear to be corroding at a different rate than the rest of the surfaces. There are a few areas of surface scratches. Ferrous corrosion runoff staining is visible on the sides of the concrete base. Dried corrosive bird droppings have etched into the surface in two (2) areas. There are moderate accumulations of bird droppings and surface soiling throughout. Plant debris from nearby trees have collected in crevices and along the bottom. Rocks are visibly wedged underneath the base in some areas. The lighting appears to be functional. When viewed at night, the entire artwork is not brightly illuminated, only the lower half "reads" well in the light.

**Recommended Site Improvements:** Monitor growth of nearby trees and ensure that branches do not overhang the sculpture. As trees grow, trim back branches accordingly. The potential for falling branches during wind events as well as excessive plant debris collecting on artwork surfaces can cause damage to the artwork.

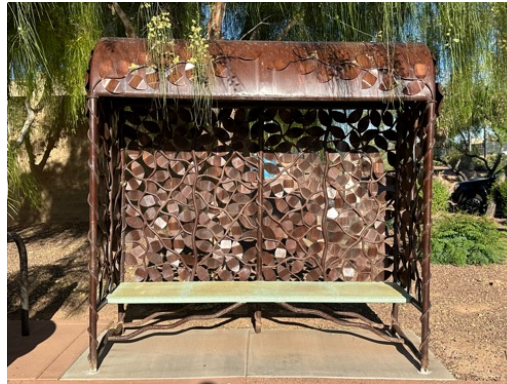
**Location:** 16126 N. Civic Center Plaza, Arts Headquarters and breezeway

**General Condition:**   Excellent           Good           Fair X           Poor

**Condition:** At the time of assessment, only four (4) out of five (5) known benches were on-site at Civic Center Plaza. One (1) bench was behind the Arts Headquarters' building beneath a willow tree. The other three (3) assessed benches are in or adjacent to the Arts Headquarters' courtyard and seating area. The fifth bench is located within the Benevilla Community Garden. For the most part the benches assessed appear to be structurally sound and secure on their mounts. One (1) bench near the Arts Headquarters' courtyard shows evidence of attempted vandalism where it appears as someone tried to steal or at a minimum remove two to three (2 - 3) of the applied leaf ornamentations. There are cracks or tears in two (2) welds as well as indentations as if someone was repeatedly hitting the leaf surface. There is additional evidence of incised graffiti and scratches in the clear coat of several leaves as well as impact damage onto leaves. Ferrous corrosion was observed forming on all five (5) of the perforated and coated bench elements. The corrosion appears to be emanating from the perforated edges and is visible in swaths over the bench surfaces. At this time, the light blue coating does not appear to be peeling or lifting. There is evidence on all five (5)

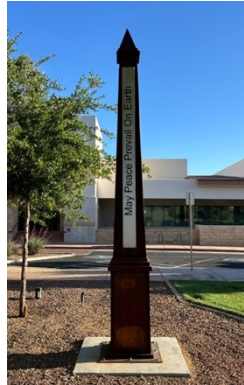
**Location:** 14250 W. Statler Plaza (Public Safety Plaza)

**General Condition:**    Excellent            Good X            Fair            Poor

**Condition:** The sculpture appears to be structurally sound and secure on its mount. The mild steel is actively corroding, though some areas do appear to have formed a relatively stable oxide layer. This is particularly visible on the undersides of edges and along seams where moisture likely collects and dwells on the surface. At the south side of the rectangular plant, there are two (2) patches of lighter or whiter mild steel surfaces that may indicate the piece was tagged and graffiti removal efforts performed or maybe there is inherently some issue with the fabrication of the steel plate itself. There are extensive accumulations of corrosive bird droppings on the top pyramid form where birds routinely perch on the sculpture. Ferrous corrosion runoff staining is visible on multiple stainless steel text plaque faces. This is likely emanating from the mild steel behind the stainless steel text plates. Insect nests were noted on the undersides of stepped forms on the surface. Plant debris from nearby trees is collecting around the base.

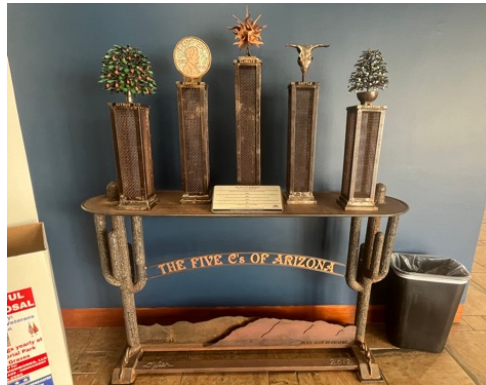
**Location:** 16089 N. Bullard Avenue (Surprise Regional Library)

**General Condition:**    Excellent            Good            Fair X            Poor

**Condition:** Overall, the artwork is stable on its mount. The surface condition is fair. There are areas of localized corrosion throughout the installation, particularly at the base, along the legs, and on each of the pedestals. The small cotton shrub sculpture and its painted components exhibit corrosion. The small cattle head sculpture displays corrosion. The small sun displays bright blue cupric corrosion and surface debris. This could be from the applied metallic flake paint, that may contain actual flakes of bronze, which can corrode and turn blue green when exposed to moisture and oxygen. The penny exhibits ferrous corrosion around the frame. The steel branches of the orange tree display ferrous corrosion with white

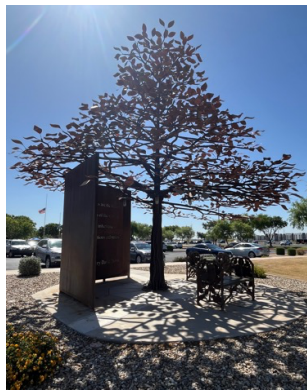
**Location:** 16089 N. Bullard Ave. (Northwest Regional Library)

**General Condition:**    Excellent            Good            Fair X            Poor

**Condition:** Overall, the installation appears to be structurally stable. The surface condition is fair. Many of the undersides of the leaves of the tree exhibit ferrous corrosion at an accelerated rate. Additional losses are assumed on the top sides of the leaves, though the installation was assessed from ground level with binoculars. It is unknown how stable the

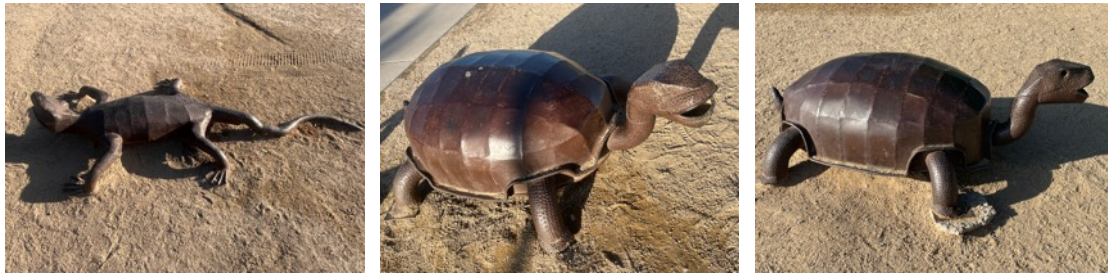
**Location:** 16089 N. Bullard Avenue (Surprise Community Park)

**General Condition:**    Excellent            Good    X                    Fair                    Poor

**Condition:** Overall, the three (3) sculptures are in relatively good condition and appear to be structurally sound. Both turtles' feet are unevenly mounted in the ground. The back of the turtle located to the south has surface scratches throughout likely from being climbed on. There are moderate amounts of surface soiling, with gravel in its mouth and along the bottom edge of its shell. Dried bird droppings and a dried pink unknown substance are visible on the turtle's back.

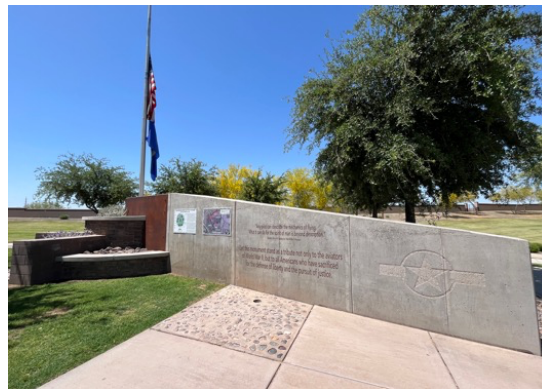
**Location:** Asante Community Park (23421 N 167th Ln, Surprise, AZ 85387)

**General Condition:**    Excellent            Good X            Fair            Poor

**Condition:** Overall, the artwork is in good condition and appears to be structurally stable. Small hairline cracks are visible in the concrete, which is typical as the forms settle and shrink with time. There is incised graffiti in the weathering steel surfaces on both sides. One (1) hex nut is missing on the east side of the weathering steel panels. There are abrasions in the concrete at the lower middle section of the east side likely due to lawncare equipment. One (1) small graffiti mark is visible on the east side's steel surface near the flagpole. Red graffiti marks are present on the concrete of the east side. Exposed ferrous mounts are visible directly below the porcelain enamel plaque likely from past signage. One (1) area on the west side of the commemorative wall displays a diamond-plated impression in the steel which is likely inherent to its fabrication. Light accumulations of surface soiling are present throughout all surfaces.

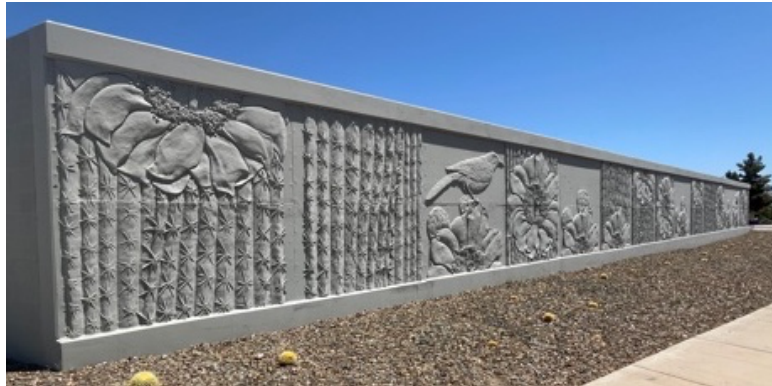
**Location:** 13430 W Westgate Drive (Public Safety Evidence & Readiness Center)

**General Condition:**   Excellent           Good X           Fair           Poor

**Condition:** Overall, the artwork appears to be in good condition and structurally stable. There are numerous vertical hairline cracks in the concrete relief. This is typical of concrete as it settles and shrinks over time and with age. Long term low level vibrations from large trucks in the area and two (2) busy roadways within five hundred feet (500') of the installation may also be contributing to hairline cracks. The flexible sealant along the bottom is failing with missing areas noted. The paint coating appears intact. Two (2) areas of applied blue transfer material, and one (1) orange transfer mark are visible on the visual lower left side. Moderate accumulations of surface soiling and insect nests are visible throughout, particularly in recessed areas.

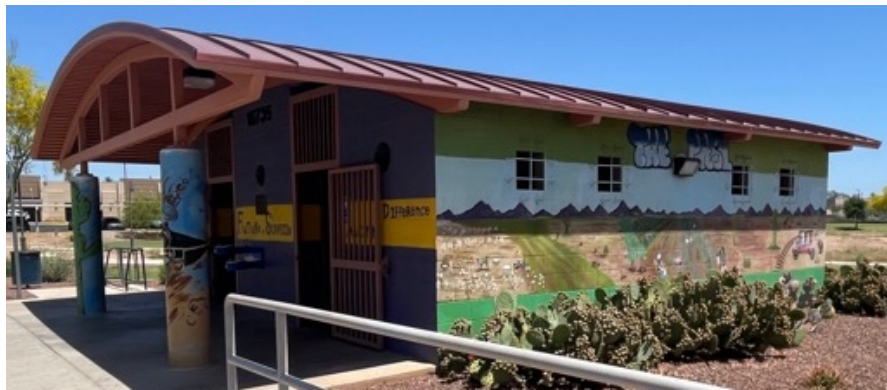
**Location:** Bicentennial Park, (16705 N. Nash Street)

**General Condition:**    Excellent            Good            Fair X            Poor

**Condition:** Overall, the artwork is in relatively good condition and appears to be stable. The painted surfaces are overall intact. There are numerous areas where the clear coat is flaking particularly on the south side. Multiple paint losses are visible on the two (2) columns at the building's front (west) entrance due to public interaction. In observation of the areas of paint loss, there appears to have been many paint campaigns, although the quantity is unknown. Areas of tape and adhesive residue are observed on both columns. A white textured

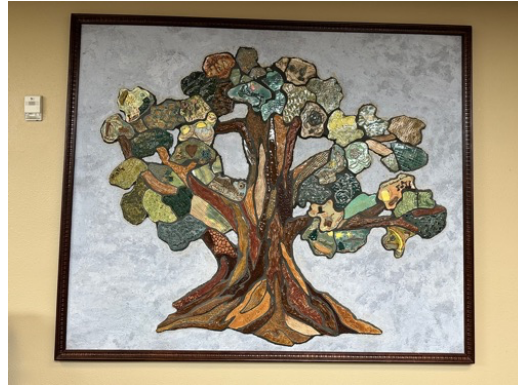
**Location:** 15832 N. Hollyhock St. (Surprise Senior Center)

**General Condition:**    Excellent            Good X            Fair            Poor

**Condition:** Overall, the composition appears to be structurally sound and in generally good condition. Hairline cracks were noted sporadically throughout the dark gray grout between tiles. There does not appear to be a noticeable pattern where the cracks are occurring. Around the outer edges/border of where the tiles meet the light blue/gray stucco material, there appears to be some type of translucent soiling or staining. It is not clear what the origin of the staining is, but it could be remnants of the gray tile grout when it was wiped back during fabrication. Along the lower wood frame, there are two gouges/abrasions in the surface close to one another. These are likely from public interaction. Light accumulations of superficial dust were noted on the horizontal surfaces and in deep recesses of the textured stucco background.

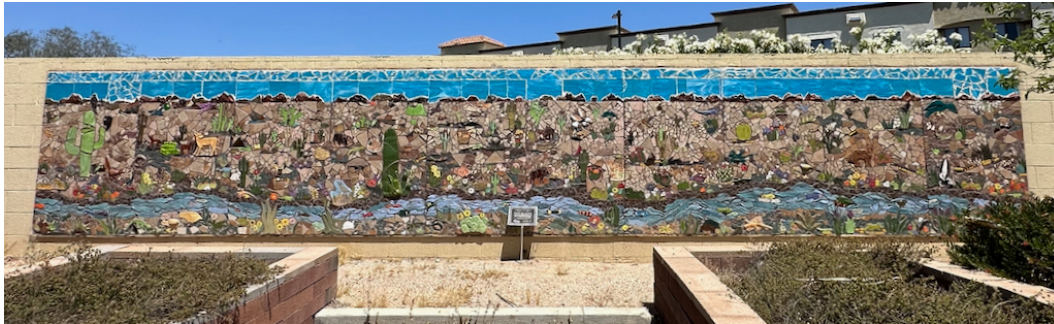
**Location:** 16752 N. Greasewood St. (Benevilla Community Garden)

**General Condition:**   Excellent           Good           Fair X           Poor

**Condition:** Overall, the mural appears to be in fair condition. The mural was visually inspected at the time of the assessment. It was not sounded due to limited time available to spend in this area before the garden needed to be locked from the exterior. The lower visual left corner is missing. It appears that at least two (2) tiles are missing from this area. Further along to the visual right, there is a crack that has formed emanating from the bottom edge upwards. The crack is relatively wide and has bisected the tail of a lizard. There is grout loss and possibly small tile loss with this crack. Another tile appears to be missing from along the bottom edge, adjacent to a seam between cement board panels. There are localized sections of brown grout along the vertical edges that have detached, exposing the cement backing board outer edges. There are many visible hairline cracks in the grout. More prominent vertical cracking is visible presumably where the joints are located between the ten (10) cement board panels. Grout loss to varying degrees is associated with many cracks in the composition. Presumably, the cause of cracking and loss is due to age and shrinkage, but also big swings in temperature between daytime and overnight. Differences in rates of thermal expansion between materials (e.g., between ceramics, glass, mortar, etc.), can result

in cracking, delamination, and surface spalls, especially when there are no expansion joints to help allow for movement in the mural system.

A particular point of clarification with the artist and City is whether or not the upper portions of the mural were sanctioned by either entity; specifically the upper blue colored glass that is not original and has been replaced. The existing blue material does not match what is depicted on the City's entry on Public Art Archive. In the images online, the sky is lighter blue in color and more harmonious overall with the composition. What is present currently is darker and visually detracting. In the previous images, the colored glass is solid whereas now the upper border and two (2) larger rectangular sections are made of various size shards of the same glass sloppily set into white thinset mortar. There is no grout between these tiles and the thinset mortar has squeezed through in between many of them, partially covering some edges. There is evidence that material in this upper area was removed and replaced. There is missing brown grout on the vertical visual right edge, which has left a brown residue on the wall. A similar residue is present along the top horizontal edge of the mural. This brown staining matches the grout color found throughout the lower surfaces of the mural. Additionally, when viewed from the sides, the profile of this upper area is not flush with the rest of the mural below. The applied mountain elements are very proud compared to other glazed ceramic tiles of similar make-up below. The same thinset mortar used to set the blue colored glass elements was also used to "grout" the gaps between the mountains and the blue "sky". Some of this material has been smeared onto artwork tiles below. The mountain tiles are detaching from the board below, resulting in large gaps between the glass, these mountain tiles, and the backer board below. Many of the rectangles of blue colored glass are cracked, some with multiple cracks. It is not clear when or why the original colored glass sky was removed and the current iteration installed. However, it is clear that the replacement materials, design, and execution are very poor. The artist should be consulted and have the area redone and returned to its original configuration as this replacement area is very visually detracting from the rest of the mural.

**Recommended Site Improvements:** As the nearby tree continues to grow, continuously cut back branches that could overhang the mural. Overhanging branches drop plant debris that can trap moisture on surfaces that promotes deterioration and micro biological growth. Birds perch on branches, which increases deposition of droppings on surfaces below. Increased shade also promotes micro biological growths. Physical damage is possible if a branch were to detach and fall onto the mural.

1. Prior to mobilization on site, work with artist to have multiple tiles re-fabricated. Artist should be engaged to remove and replace the existing sky component with material that is more in alignment with their original vision and composition.

6. Inject areas of delamination with micro injection grout to stabilize.
7. Remove, clean, and re-set any loose tiles. Set replacement tiles provided by the artist with appropriate thinset mortar.

8. Remove loose, de-bonded grout and replace in kind. Replace missing grout along vertical edges with original grout to match.
9. Patch crack through the lizard's tail with an exterior-grade patching material that is compatible with ceramic substrates.

10. Discuss with the artist and City whether or not the vertical cracks at seams between cement boards should be routed and filled with a flexible sealant material to allow for expansion/contraction/movement and serve as expansion joints.
11. Apply a vapor-permeable sealant to all surfaces once the replacement sky element has been installed and grouted by the artist.

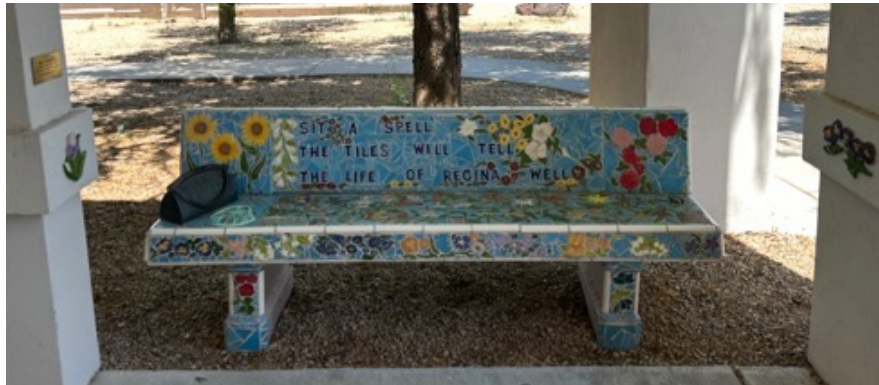
**Location:** 15832 N. Hollyhock St. (Surprise Senior Center)

**General Condition:**    Excellent            Good X            Fair            Poor

**Condition:** Overall, the bench appears to be structurally sound. The condition is relatively good given its location outdoors, public use, and deferred maintenance. A hairline crack in the grout runs along the top edge of the seatback, where the tiles are applied to the vertical face of the seatback. On this top edge, there is also two (2) broken tile fragments and associated grout loss. Similar cracking was noted on the visual right vertical plane of the seat, near the front corner. Grout (and possibly tile) loss was noted on the front vertical plane of the seat. The bronze purse does not appear to be lacquered. The patina is generally uniform, though the surface appears dry/parched due to a lack of protective wax coating.

The tiles and grout appear generally soiled, particularly the grout at the visual right side of the bench seat. This may be where most people sit on the bench, which would explain the higher degree of soiling. Plant debris, insect nests and webs, as well as micro biological growths were noted on the surface. Bio growths are particularly noticeable in the grout between tile fragments and where water presumably drains at the corners between the seatback and seat. Plant debris collects significantly at the bronze purse. White paint drips and transfer were noted on the bronze purse, as well as the pansy flowers mounted to the arch wall.

**Recommended Site Improvements:** Trim back tree branches so they do not overhang the artwork.

1. Document treatment with a written report and high-resolution photography.  
Provide recommendations for routine maintenance as well as a Dropbox link to all treatment images.
2. Dry-brush surfaces to remove loose particulate matter and debris.
3. Wash surfaces with filtered tap water and a masonry detergent.
  - a. Rinse surfaces with distilled water and remove all standing water.
4. Remove extant paint accretions with appropriate organic solvent(s).
5. Apply a non-toxic biocide to all surfaces to mitigate microbiological growths.
6. Route cracks and inject with a masonry micro-injection mortar to stabilize.
7. Fill losses in grout in kind.

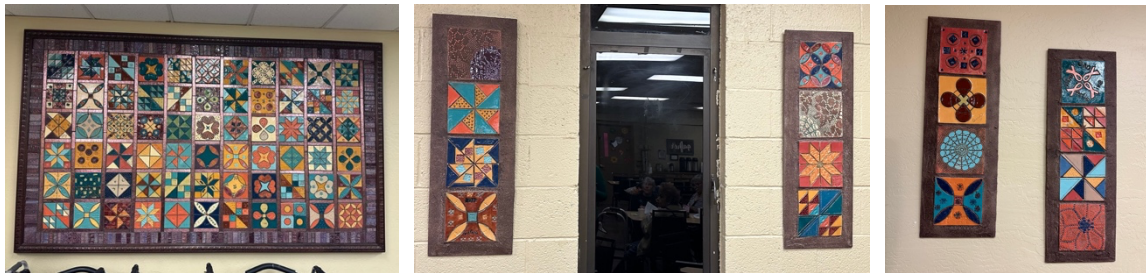
**Location:** 15832 N. Hollyhock St. (Surprise Senior Center)

**General Condition:**    Excellent            Good X            Fair            Poor

**Condition:** Overall, the installation appears to be structurally sound and in good condition. Once (1) small glaze chip was noted on a tile in the larger quilt composition. A localized area of paint accretion was also noted on this mural. Cream paint transfer from re-painting the surrounding wall was noted around the edges of the wood frame. There appear to be several scratches across the tinted grout surfaces of several of the smaller vertically oriented mural vignettes.

**Comments on Safety/Risk Management:** Mounting hardware for the four (4) small vertical pieces should be replaced and made more stable, possibly with Z-clips or other form of cleat system.

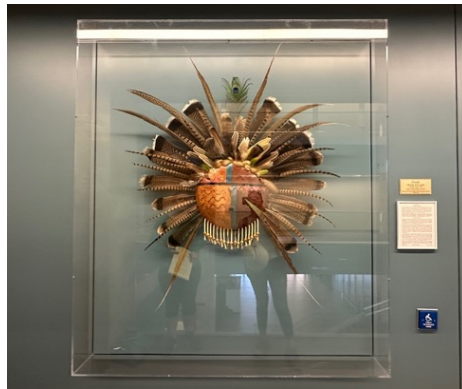
**Location:** 2<sup>nd</sup> Floor of City Hall, 16000 N. Civic Center Plaza

**General Condition:**    Excellent            Good X            Fair            Poor

**Condition:** Overall, the sculpture/mask appears to be in good condition and secure on its mount. The work was assessed from outside of the acrylic vitrine. Dust bunnies and what appear to be spider webs were noted on the hanging beads and multiple feathers. Light to moderate accumulations of dust were noted on top of and within the case, on horizontal surfaces. Abrasion scuffs and scratches were noted on the front exterior surfaces of the case, closer to the floor. Liquid accretions in a splatter/droplet pattern were observed on the exterior surfaces of the vitrine/case.

**Recommended Site Improvements:** Locate any overhead HVAC vents that may blow hot and/or cold air directly onto the vitrine. Even though the mask is protected from direct airflow, this could still adversely impact the temperature within the vitrine, creating a micro-climate. The vitrine does not appear to be specifically climate controlled.
